Development of a high sensitivity ultrasonic phased array non-destructive testing method for early detection of creep damage in alloy steels used in high temperature/CreepTest

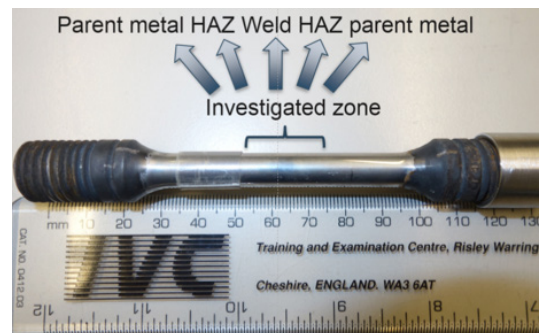
1st unbroken reference sample with the creep damage inside the weld

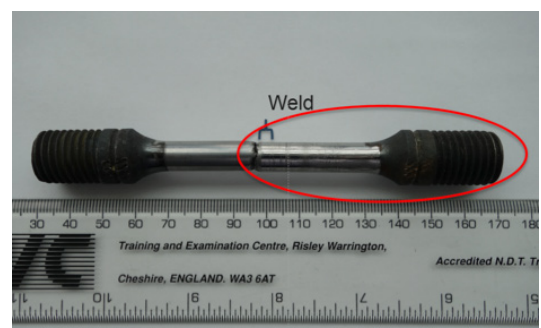
2nd reference sample after the breakage due to the development of the creep damage

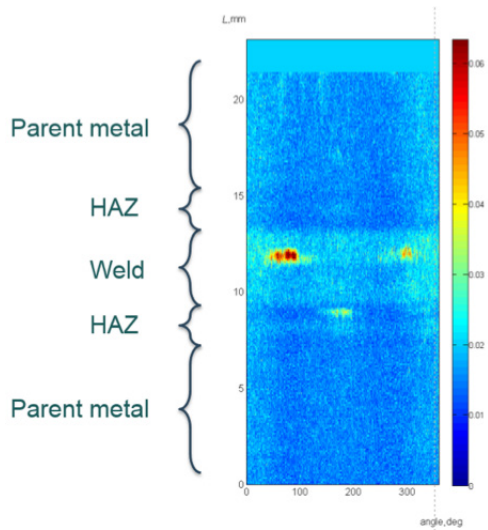
The B-scan of the 1st reference sample showing the structural noise along different regions of the sample and indicating start of creep damage

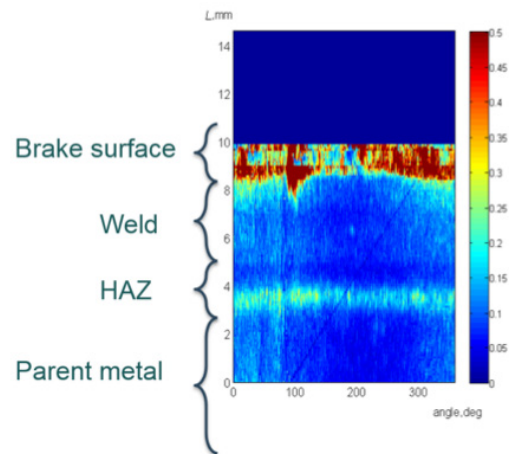
The B-scan of the 2nd reference sample showing the structural noise along different regions of the sample and indicating strong creep damage

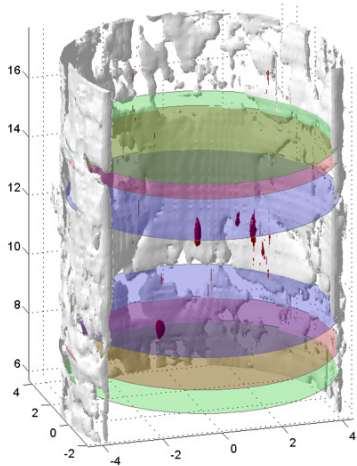
Reconstructed 3D ultrasonic image of the 1st sample

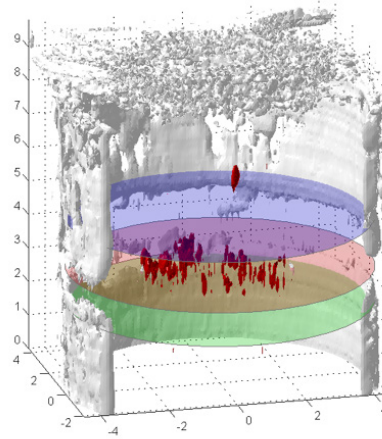
Reconstructed 3D ultrasonic image of the 2nd sample
